## TEVES IV ABS WARNING LIGHT ON - OPEN CIRCUIT

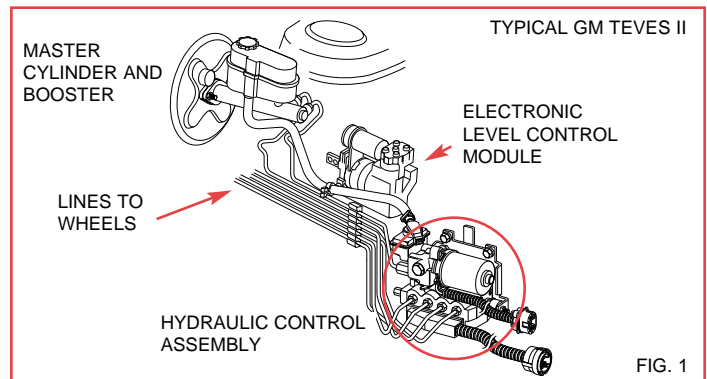
On Some Teves ABS systems the warning light can come on without an obvious visual cause such as a damaged wheel speed sensor or loose wiring harness. The cause can be brake fluid leakage in the hydraulic control assembly, figure 1. When a scanner is used to retrieve trouble codes on Chrysler, Ford, and General Motors vehicles and the codes pertain to solenoid malfunction, the valve block assembly should be suspected. This may also be referred to as the pressure modulator assembly.

The hydraulic control assembly consists of a reservoir, a pump and motor assembly, and a pressure modulator (solenoid) valve assembly.

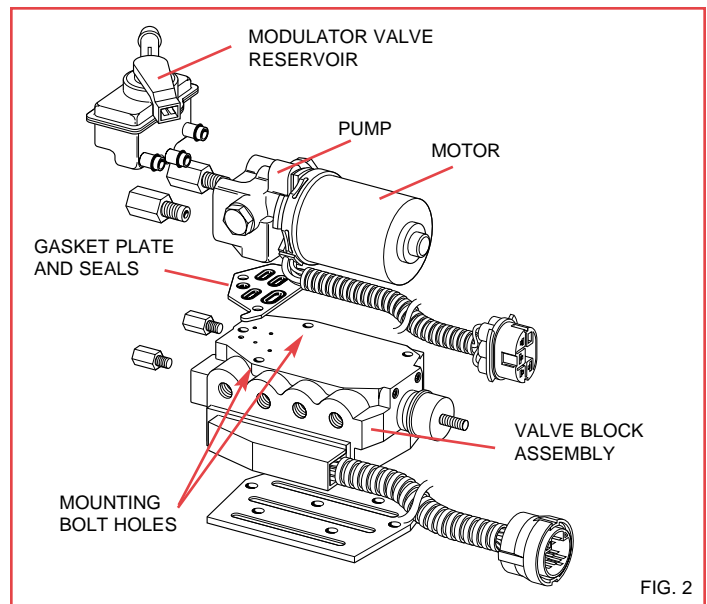
There is a metal gasket with O-rings between the pump and valve body, figure 2. The O-rings in the gasket can deteriorate. The repeated cycling of the pump can accelerate the wear or deterioration of the O-rings. If the O-rings have deteriorated sufficiently, brake fluid can leak into the valve body containing the solenoids through the mounting bolt holes. When sufficient fluid has entered this area, it can saturate the flexible printed circuits (ribbon cables) and cause a malfunction in the solenoid valve circuit, figure 3.
